[Federal Register Volume 76, Number 93 (Friday, May 13, 2011)]

[Docket No. FAA-2010-1101; Directorate Identifier 2009-CE-013-AD; Amendment 39-16690; AD 2011-10-09]

Airworthiness Directives; Cessna Aircraft Company Models 150, 152, 170, 172, 175, 177, 180, 182, 185, 188, 190, 195, 206, 207, 210, T303, 336, and 337 Airplanes

ACTION: Final rule.

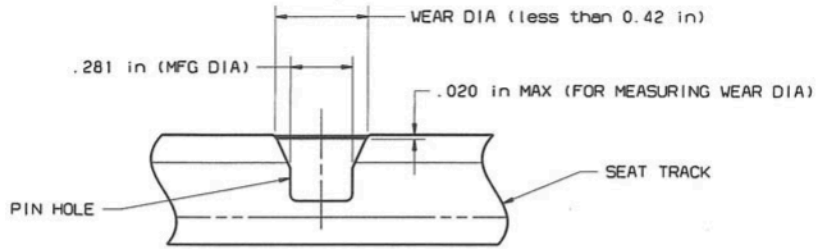
Figure 1. Diameter of seat pin locking engagement hole

We disagree with this comment. The measurement dimensions in figure 1 adequately address the measurements necessary for this AD. Additional measurements will not provide any additional benefit.

(3) Inspect the diameter of each seat locking pin engagement hole in the pilot and copilot seat rails for excessive wear. Due to wear on the rail surface at the hole opening, we allow this measurement 0.020 of an inch below the surface of the rail. You must take this measurement somewhere between the surface of the rail or no more than 0.020 of an inch below the surface of the rail.

(i) If the diameter of any of the holes is 0.42 of an inch or more (see figure 1), before further flight, replace the rail.

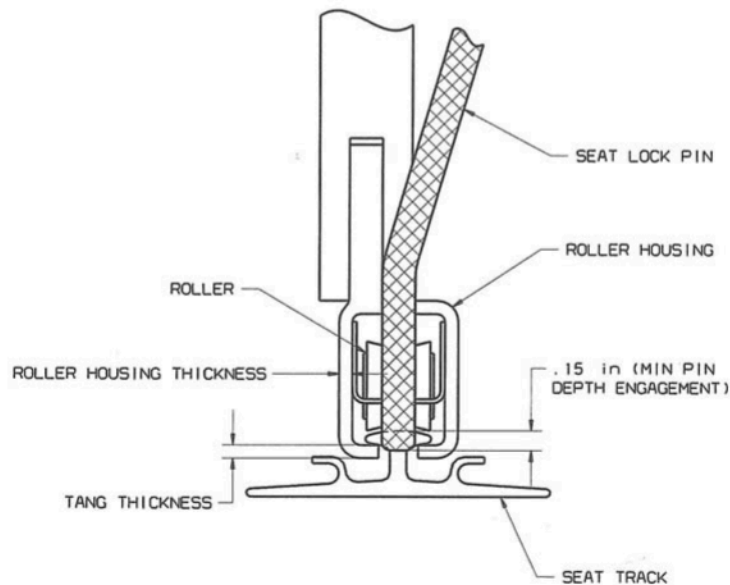
Figure 2. Seat locking pin depth engagement

(5) Inspect the thickness of the tang (see figure 2 and figure 3). Due to wear of the tang chafing against the seat rail, measure the tang thickness where the tang inner edges contact the seat rail.

(10) Lift up the forward edge of each seat to eliminate vertical play of the seat locking pin in the engagement hole, and from this position, inspect the depth of engagement of each seat locking pin (see figure 2). If the rail is worn, this depth is measured from the worn surface, not the manufactured surface.

(i) If engagement of any of the seat locking pins measures less than 0.15 of an inch, before further flight, replace or repair any seat components necessary to achieve a seat pin engagement of a minimum of 0.15 of an inch.

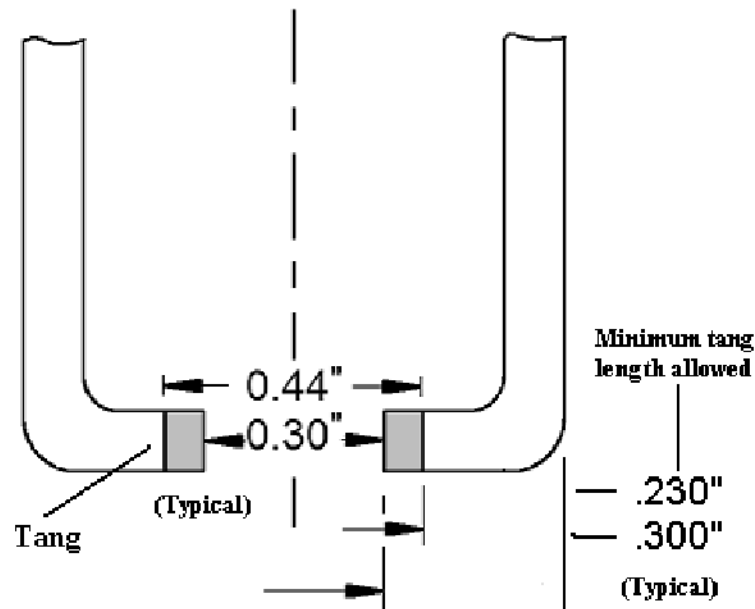
Figure 4. Closeup of seat roller housing and tang gap width

We agree with this comment. We agree that measuring the tang length inside of the roller housing is difficult because of the presence of the rollers inside of the roller housing.

(6) Due to wear or deformation of the tangs, inspect the tang length from the inner edge of the tang to the outer edge (the bend area) of the roller housing (see figure 4).

We have changed the callouts in figure 4 to measure the tang length from outside of the roller housing instead of from inside of the roller housing. We have also changed the description of the tang measurement in figure 4 to more accurately describe the measurement.

(i) The minimum measurement allowed for the remaining tang length is 0.230 inches remaining on either of the tangs, from the inner edge of the tang to the outer edge (the bend area) of the roller housing. If the measurement is less than 0.230 inches on either of the tangs, before further flight, replace the roller housing.

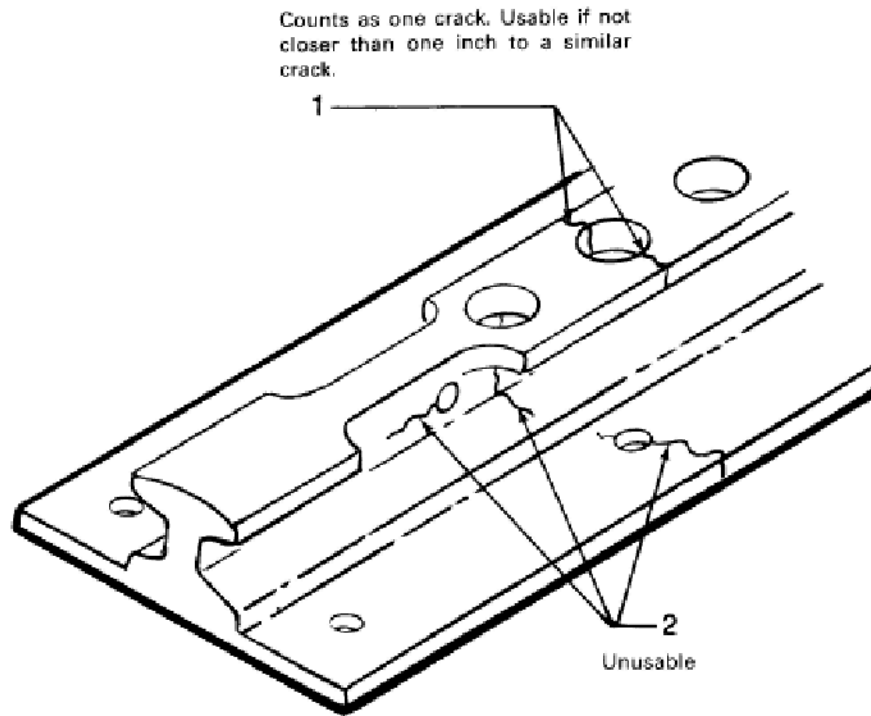
Figure 5. Seat rail

(8) Visually inspect the seat rails for cracks.

- (1) Any portion of web or lower flange is cracked (index 2).
- (2) Any crack in crown of rail is in any direction other than right angle to length of rail.
- (3) Number of cracks on any one rail exceeds four, or any two cracks (index 1) are closer than one inch.

(i) If there are seat rail cracks that exceed the crack criteria in figure 5, before further flight, replace the seat rail.

REPLACE SEAT RAIL WHEN:
